# Property Visit Report

| <b>Client</b> | Mr & Mrs Example | <b>Report no.</b> | IPW-SAMPLE-001 |
| <b>Property</b> | Sample Cottage, Seaview, Isle of Wight | <b>Plan</b> | Standard (2 visits/month) |
| <b>Visit date</b> | Tuesday 14 October 2026 | <b>Time on site</b> | 10:05 – 10:50 |

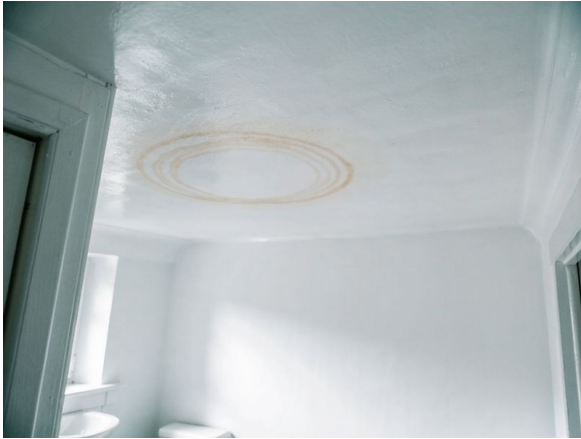
**Photo 1:** Bathroom ceiling · 10:21

| Item checked | Status | Notes |
|---|---|---|
| Ceilings & walls: damp, stains, mould | Issue | Faint tide-mark rings on bathroom ceiling, about 30 cm, dry to touch (photo 1) |

| # | Issue found | Location | Priority | Recommended action |
|---|---|---|---|---|
| 1 | Faint water mark on ceiling, dry to touch | Bathroom ceiling | Medium | Probably from wind-driven rain at the roof flashing above. To be re-checked at the next visit. If it has grown, a roofer will be arranged to inspect (quote first, with your approval). |

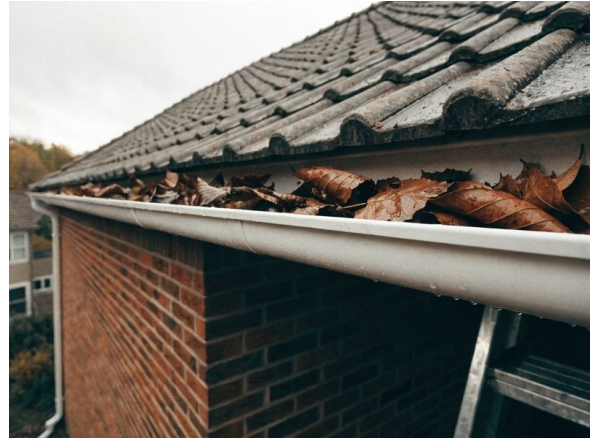
**Photo 2:** Rear gutter · 10:09

| Item checked | Status | Notes |
|---|---|---|
| Gutters & downpipes | Issue | Rear gutter partly blocked with leaves (photo 2) |

| # | Issue found | Location | Priority | Recommended action |
|---|---|---|---|---|
| 2 | Leaves building up in gutter | Rear elevation | Low | Book a gutter clear before winter to prevent overflow onto the rear wall. A local contractor can be arranged on request. |

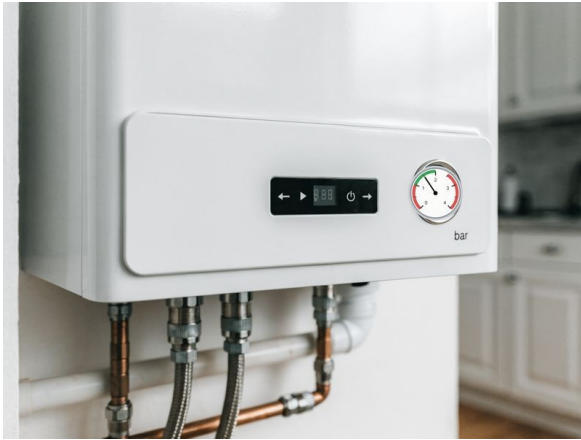
**Photo 3:** Boiler pressure · 10:30

| Item checked | Status | Notes |
|---|---|---|
| Heating & boiler | OK | Pressure 1.4 bar. Frost setting on (photo 3) |

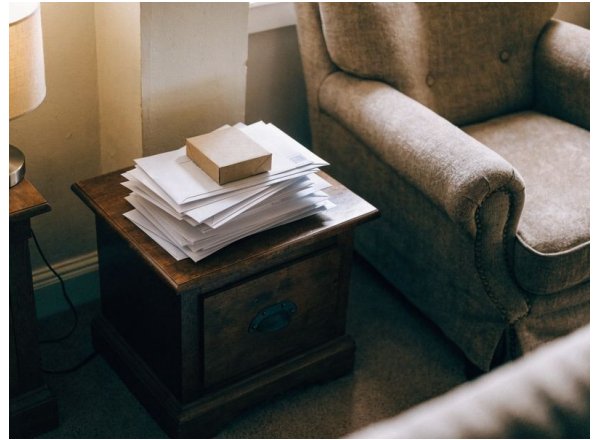
| Item checked | Status | Notes |
|---|---|---|
| Post cleared | OK | About 15 items and 1 parcel, placed out of sight on sitting-room cabinet (photo 4) |

**Photo 4:** Post, out of view from windows · 10:12
